REPORT OF INVESTIGATION

Underground Coal Mine

Fatal Powered Haulage Accident October 20, 2007

Pleasant Hill Mine Carter Roag Coal Company Mabie, Randolph County, West Virginia ID No. 46-08194

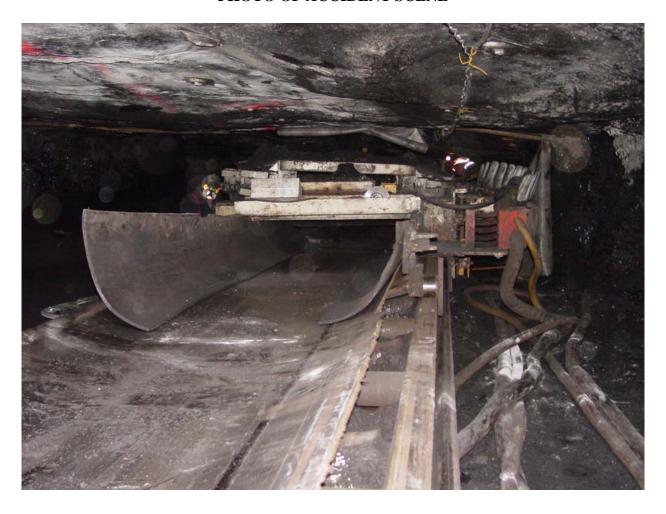
PHOTO OF ACCIDENT SCENE

On Saturday, October 20, 2007, an electrician, Howard "Tim" Harris was fatally injured when he apparently fell onto the mobile bridge carrier dolly which mounts onto the Lo-Lo belt. The victim was traveling along the tight side of the Lo-Lo belt to retrieve his multimeter, (located on the opposite side of the belt) at the time of the accident. The operator did not have any written plans, policies, or procedures established to prevent miners from traveling along the tight side of the Lo-Lo belt.

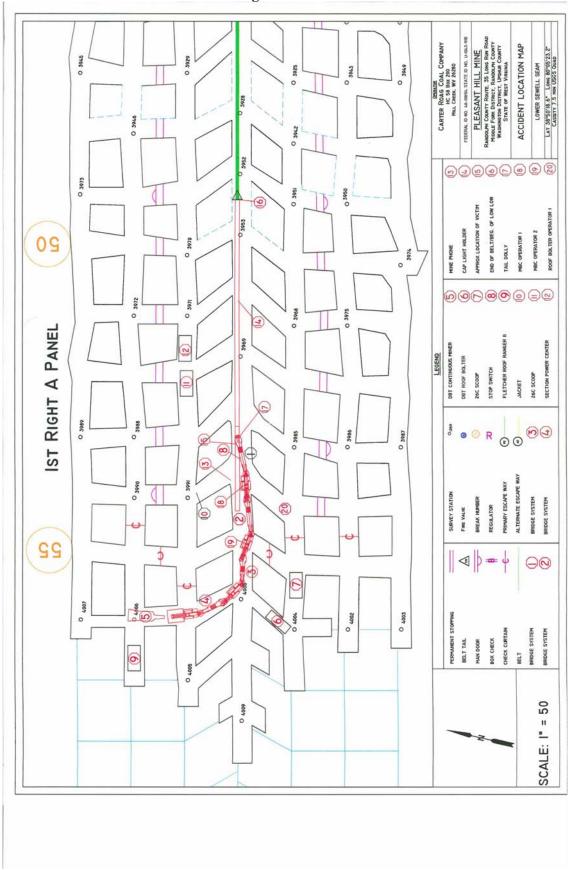
APPENDIX BScale Drawing of the Accident Scene

All of the disabling devices on all four mobile bridge conveyor units functioned properly when tested. Each mobile bridge was also equipped with a voice communication system consisting of headphones with microphones. The communication system was limited to the bridge operators only. The Number 4-Bridge Operator maintained a separate radio to communicate with other radio carriers on the section. All communication devices functioned properly when tested. The average height in the area of the Number 1-Mobile Bridge Operator was 48 inches. A pinch point existed where the mobile bridge carrier dolly attached to the Lo-Lo belt. The center of the Lo-Lo belt to the dolly frame was 10 inches at this location. The victim was caught in this area. Additionally, the distance from the solid rib to the mobile dolly was three feet six inches from the tight side coal rib at the accident scene and was not a contributory factor to the cause of the accident. See Appendix B for a scale drawing of the accident scene.

While traveling along the tight side of the Lo-Lo belt, the electrician was fatally injured when he apparently fell onto the mobile bridge carrier dolly that mounts onto the Lo-Lo belt. The victim was dragged under the mobile bridge carrier dolly. The operator had no written plans, policies, procedures or administrative controls to prevent miners from traveling along the tight side of the Lo-Lo belt.
